Limited Visual Dam Safety Inspection Summary Report

MA-090

Reservoir 92

May 2006

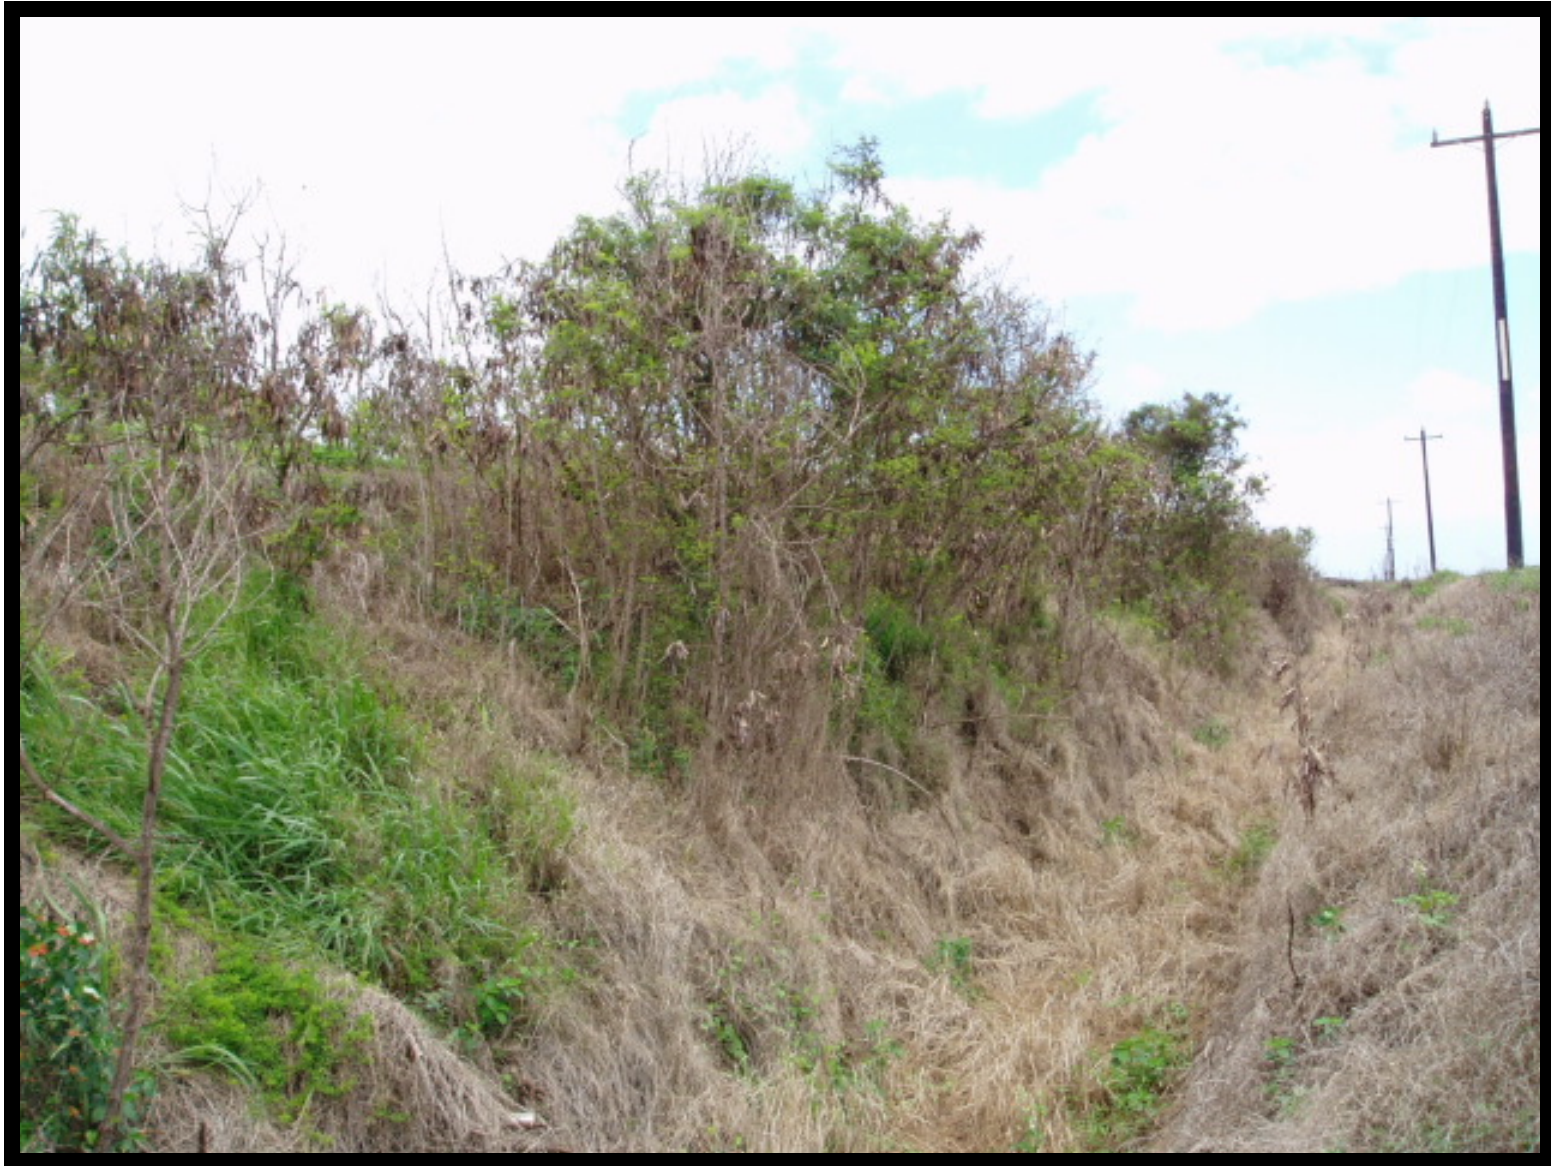
There was minor surface erosion at the time of inspection.

There was Haolekoa brush on the slope. The owner should continue with removal of vegetation.

- a. The downstream slope appeared to be in fair to poor condition and requires corrective action.
- b. The down stream slope was not visible due to high grass and bush vegetation. Clear high vegetation and maintain low to enable easy visual inspection.

090 downstream 1 - Downstream slope. Note dense vegetation on the slope.

- c. Tree(s) were observed on the downstream slope. Trees have been identified as the probable cause of piping failures, and can possibly cause severe damage to the embankment if they are uprooted during high winds. Corrective action is required to remove the tree hazards from the dam. Acceptable remedies include removal of the tree and its root structure down to a 2" diameter and reconstruction the damaged embankment section. All repair work shall be accomplished as per the requirements of licensed geotechnical or structural engineer. Routinely monitor the damaged area for signs of settlement and seepage.
- d. The slope was very steep, around a 1 to 1 slope; further study is required to verify slope stability.

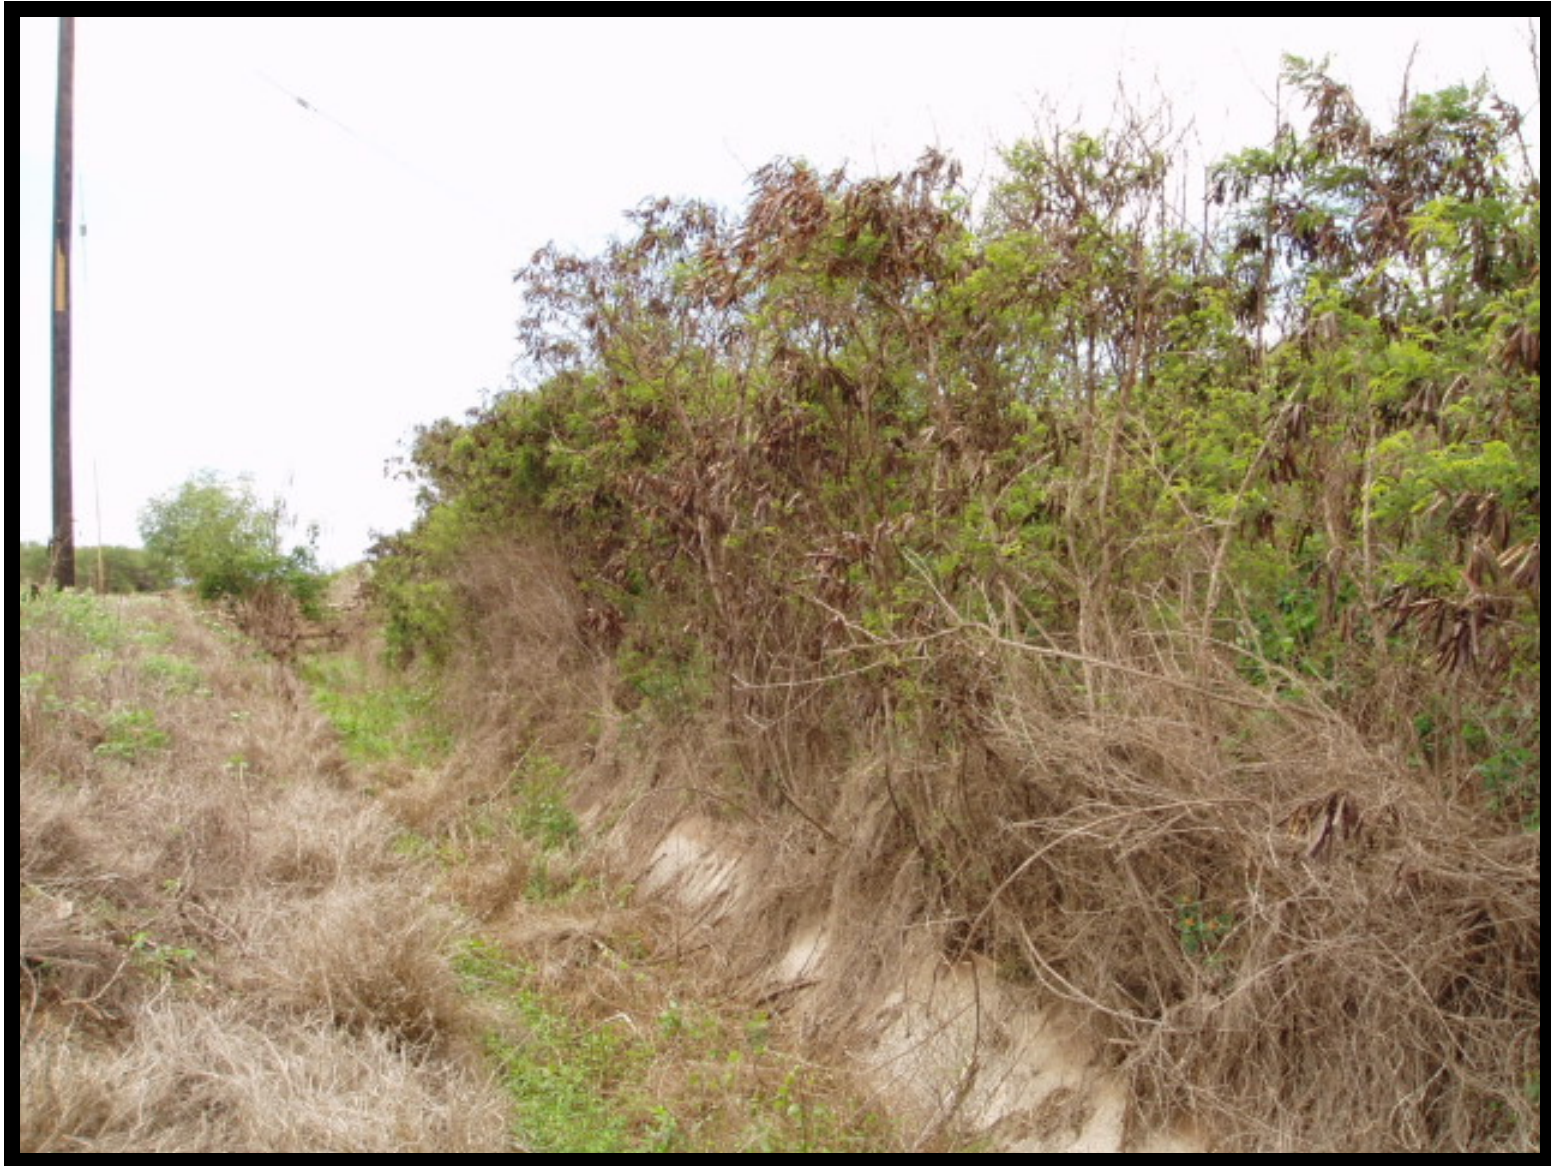
090 downstream 2 - Downstream slope. Note dense vegetation on the slope.

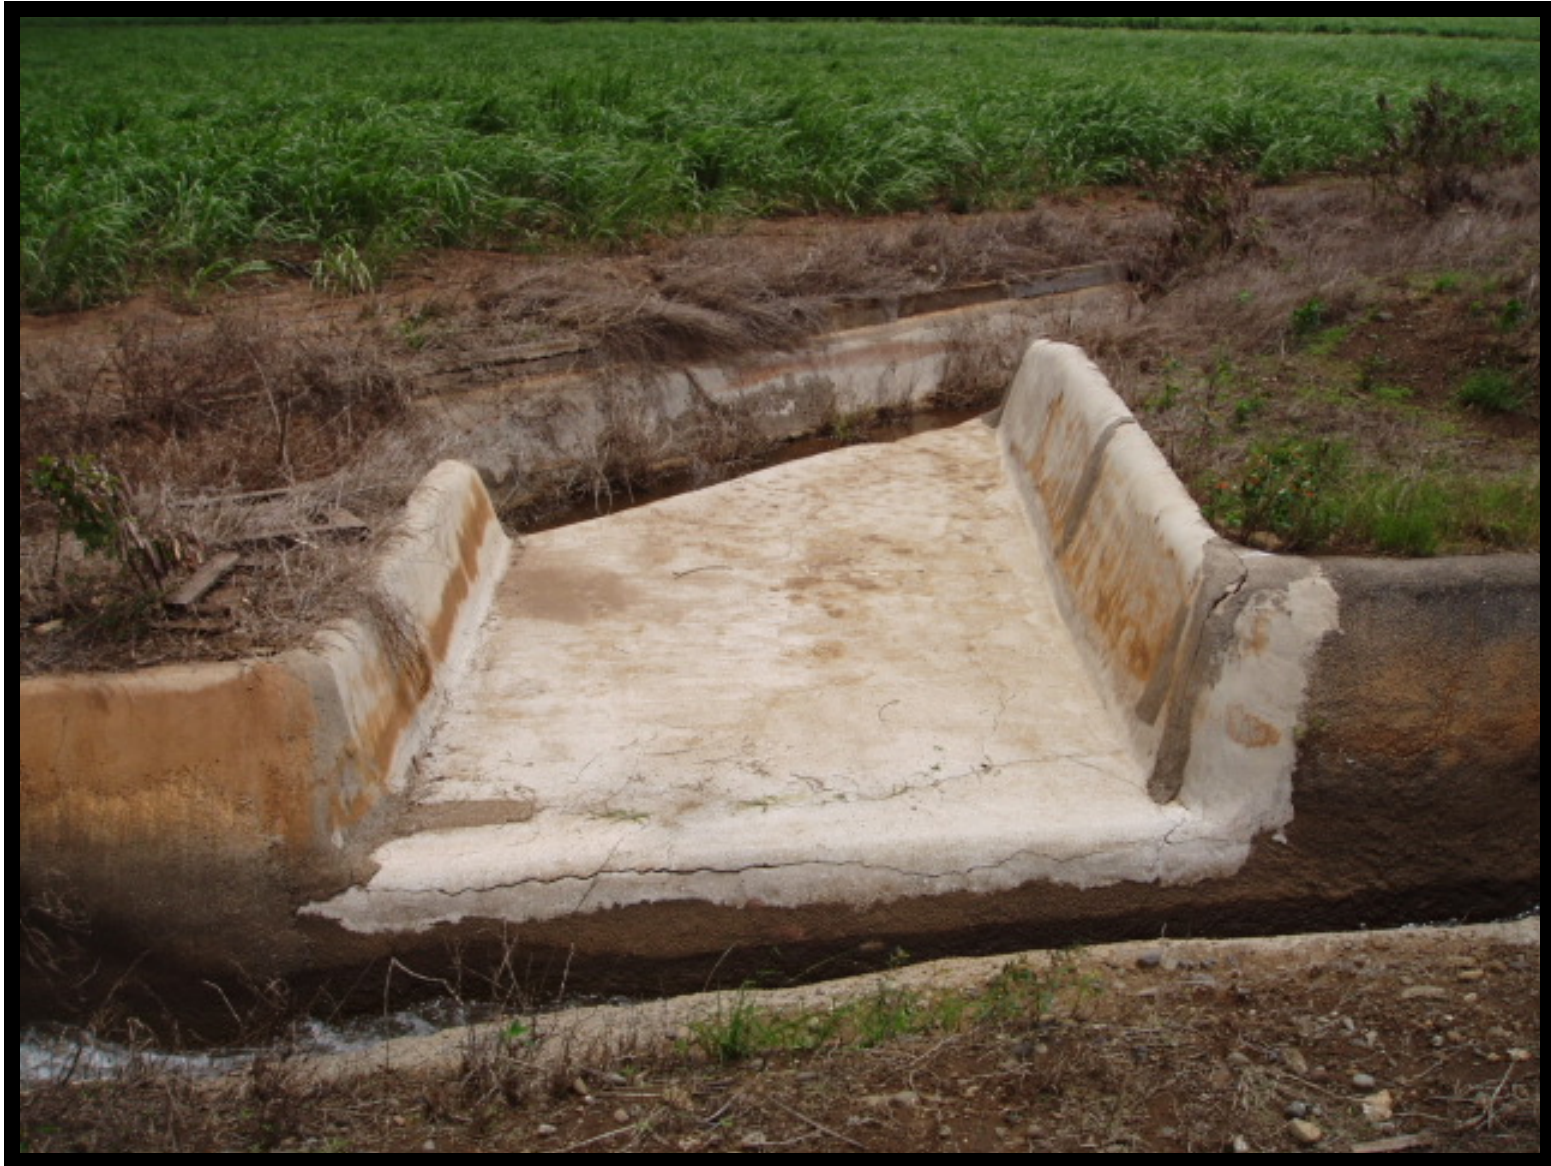
090 spillway

The spillway slope protection is of concrete.

The dimension is 9 feet. The invert elevation is 103 feet per NGVD.

Erosion was not observed at the time of inspection.

- a. The Spillway appeared to be in satisfactory condition, no corrective actions are required at this time.

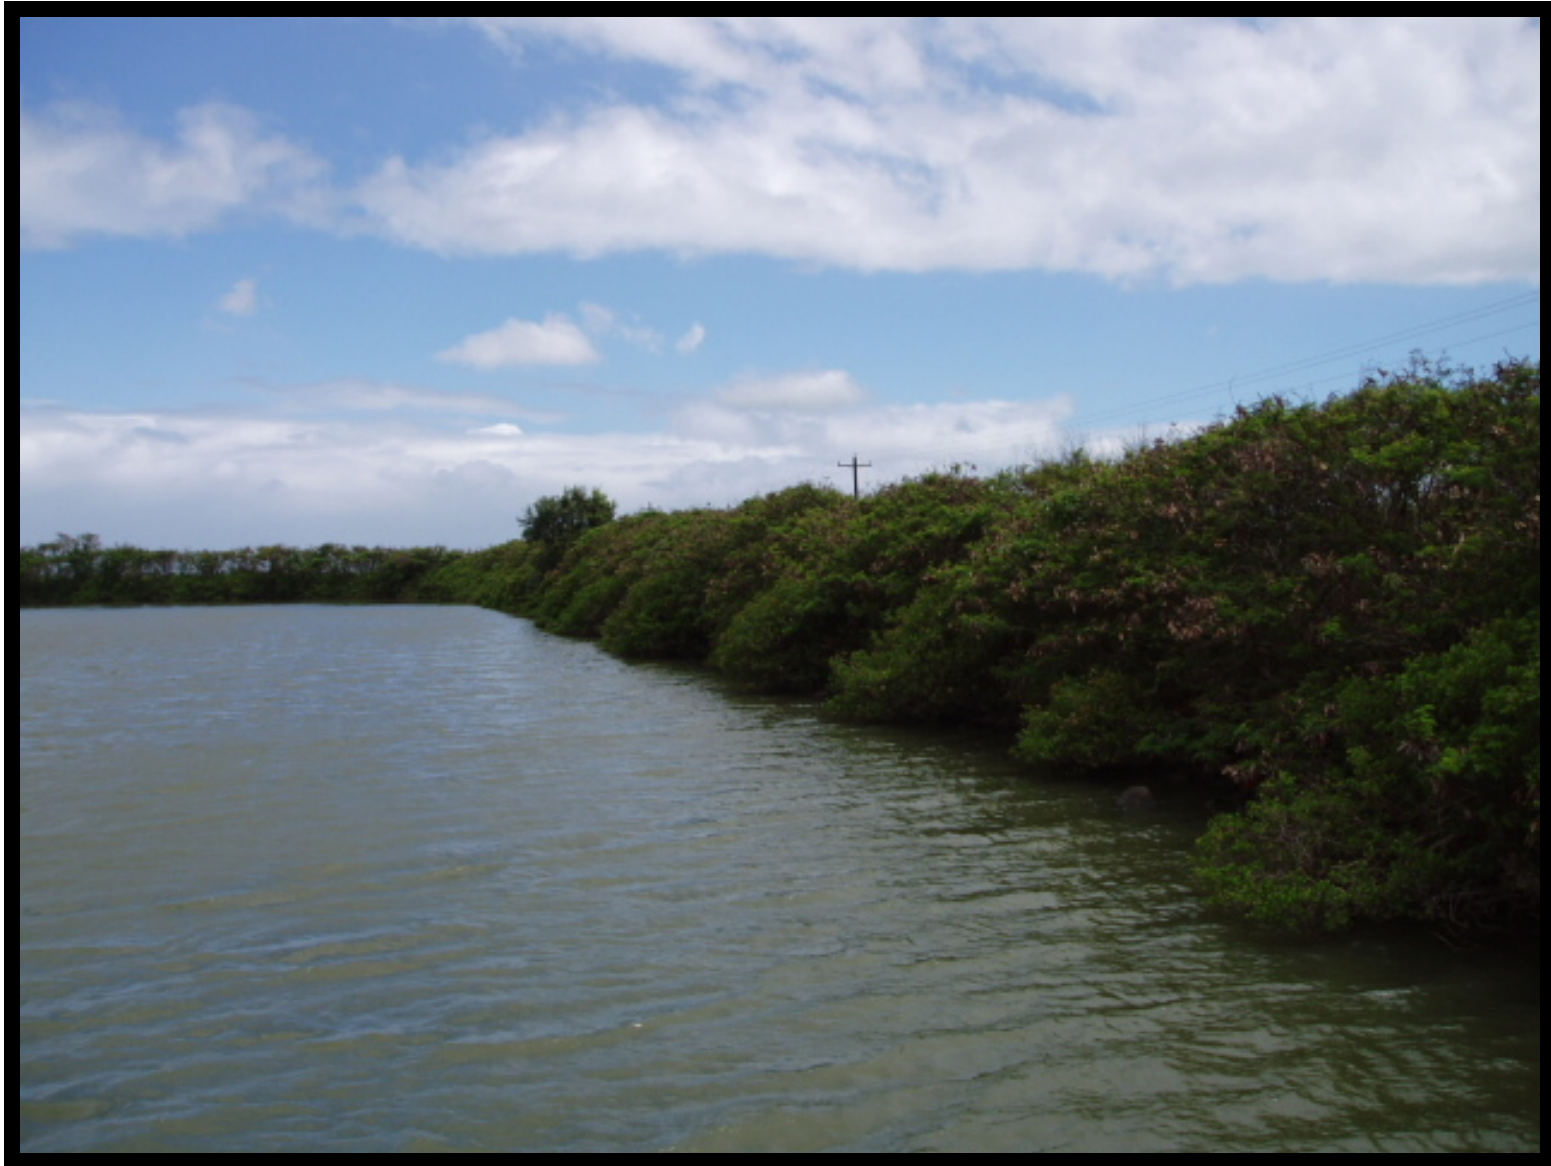
Inspection of slope was difficult to inspect due to dense vegetation.

- a. The upstream slope appeared to be in fair to poor condition and requires corrective action.
- b. The upstream slope was not visible due to high grass and bush vegetation. Clear high vegetation and maintain low to enable easy visual inspection.
- c. Tree(s) were observed on the downstream slope. Trees have been identified as the probable cause of piping failures, and can possibly cause severe damage to the embankment if they are uprooted during high winds. Corrective action is required to remove the tree hazards from the dam. Acceptable remedies include removal of the tree and its root structure down to a 2" diameter and reconstruction the damaged embankment section. All repair work shall be accomplished as per the requirements of licensed geotechnical or structural engineer. Routinely monitor the damaged area for signs of settlement and seepage.

090 Upstream slope of the dam. Note trees on the slope.

The owner needs to regularly remove vegetation from slopes.

- ☒ j. Tree(s) were observed on the dam embankment. Trees have been identified as the probably cause of piping failures, and can possibly cause sever damage to the embankment if they are uprooted during a high winds. Corrective action is required to remove the tree hazards from the dam. Acceptable remedies include removal of the tree and its root structure down to a 2" diameter and reconstructing the damaged embankment section. All repair work shall be accomplished as per the requirements of licensed geotechnical or structural engineer. Routinely monitor the damaged area for signs of settlement and seepage.
